Short-term clinical evaluation of fixed zirconium-based restorations on implants.

T. Linkevicius, E. Vladimirovas, S. Grybauskas, A. Puisys.
Vilnius Center of Implantology

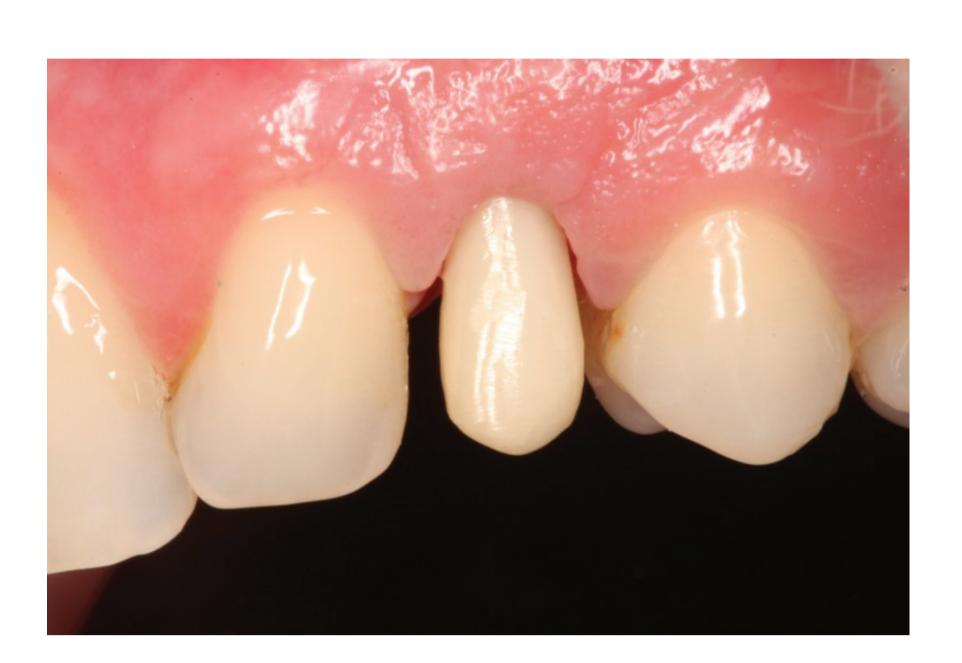
Figure 1. Framework of zirconium-based crown.

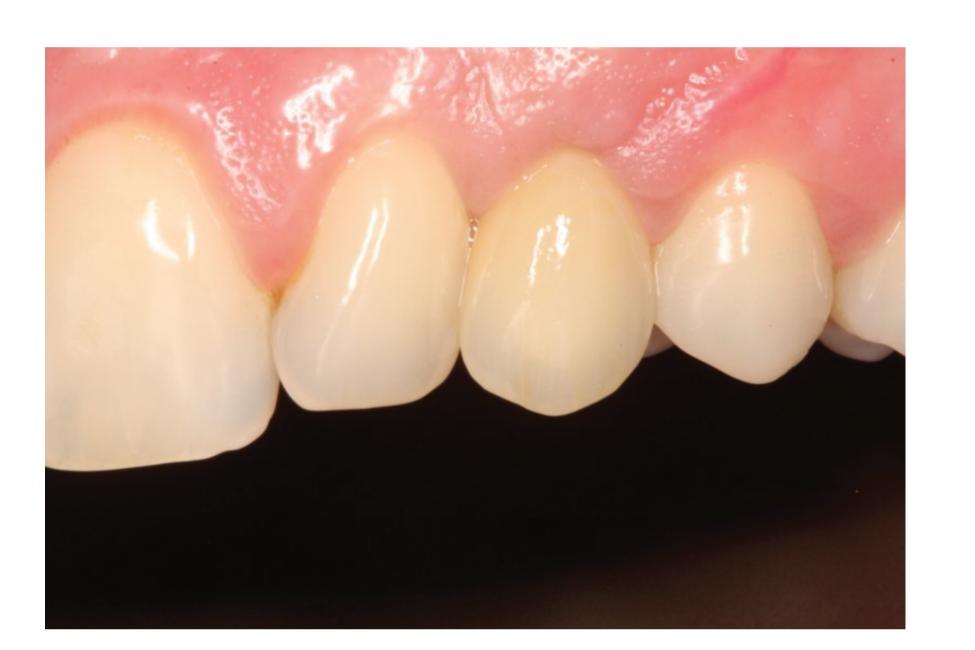
Figure 2. Zirconium-based crown.

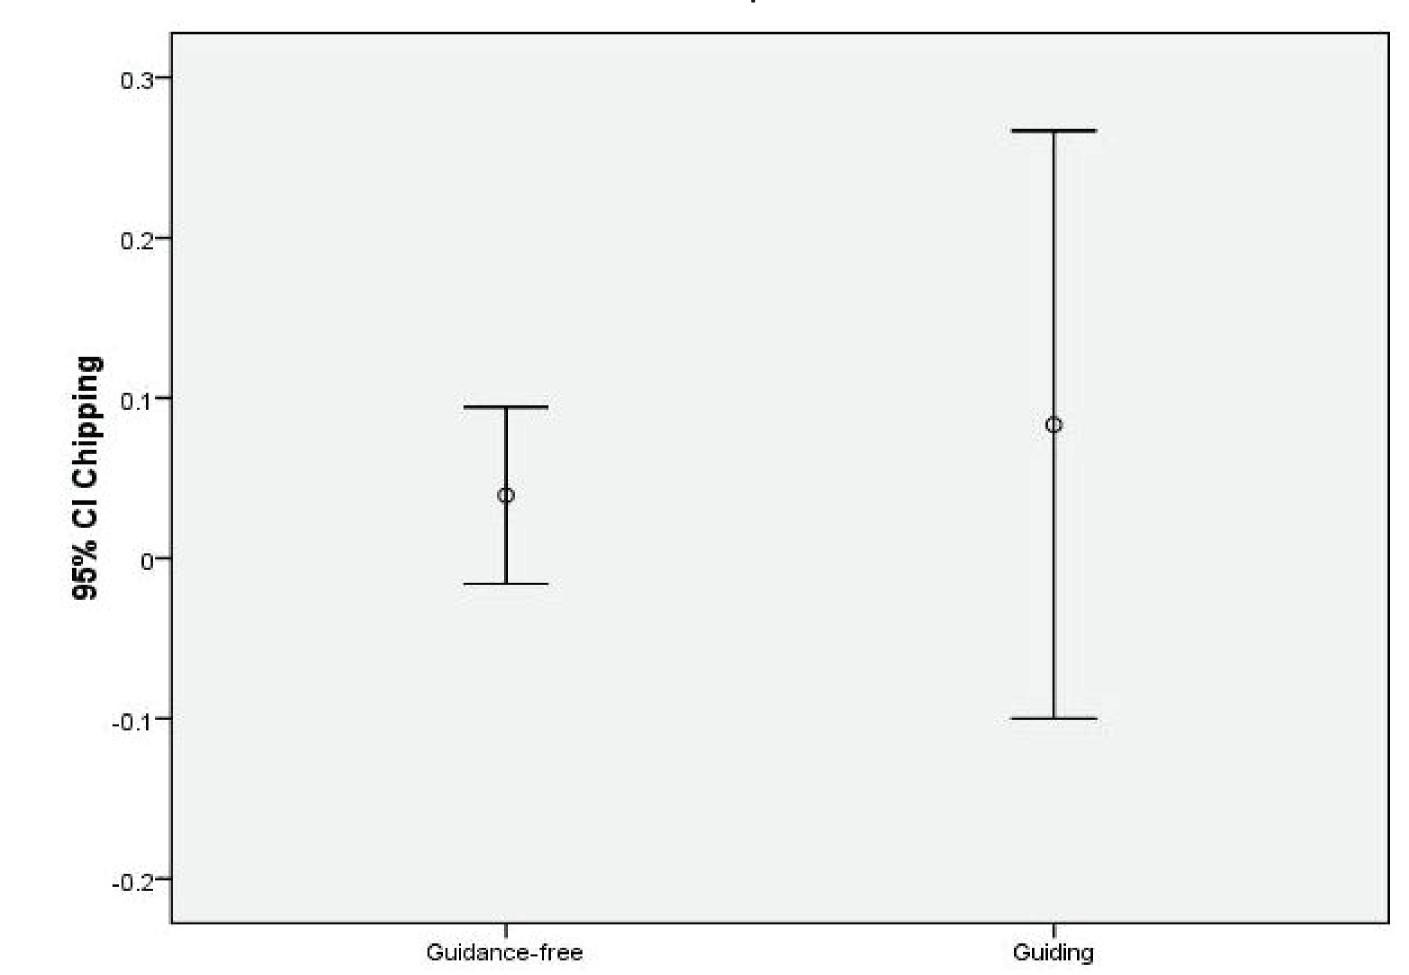
Figure 3. Guidance had no statistically significant difference on complication rate.

All implants were successful at the moment of evaluation. No fracture of framework was registered, restorations were in function. Mean ceramic fracture rate was 4.8% as fracture occured in 3 restorations. Mean follow-up time was 12 months, ranging from 6 to 29 months. According to the data available 1 fracture (4.16%) occured in anterior segment and 2 – in lateral segment (5.12%). There was 1 failure in group of single crowns (2%) and 2 (16.6%) in FPD group. In-Ceram zirconia system encountered 2 fractures (4.7%), Zirconzahn – 1 fracture (14.32%). One ceramic fracture (20%) occurred in lateral guidance group, 2 failures – in guidance-free group (3.9%).
